Sloan Flushometer

PARTS LIST

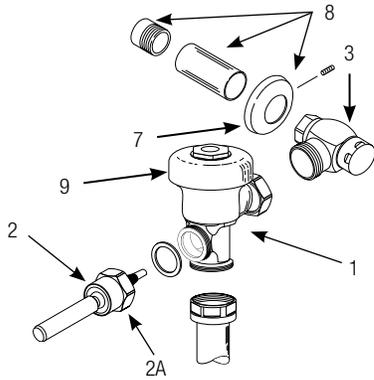
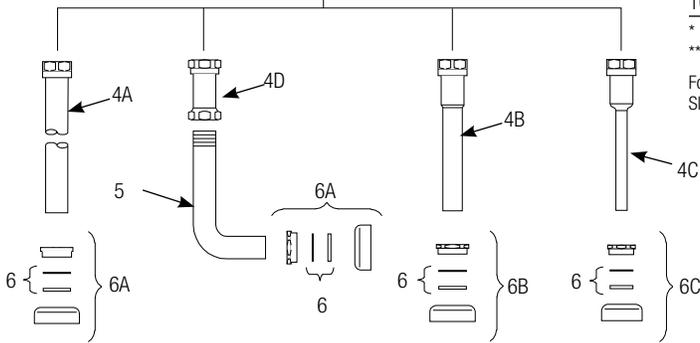
Item No.	Code No.	Part No.	Description
1.	—	A-3-A	Valve Assembly – contact Tech Support for proper assembly
2.	0302390	B-73-A	ADA Compliant Handle Assembly
2A.	0301082	A-6	CP Handle Coupling

3.	—	H-710-A	Bak-Chek® Control Stop – 3/4" or 1"
4A.	5323007	V-500-AA	1-1/2" (38 mm) x 9" (229 mm) Vacuum Breaker Assembly ** – 6 per package
4B.	5323006	V-500-AA	1-1/4" (32 mm) x 9" (229 mm) Vacuum Breaker Assembly – 6 per package
4C.	5323005	V-500-AA	3/4" (19 mm) x 9" (229 mm) Vacuum Breaker Assembly – 6 per package
4D.	—	V-500-A	Vacuum Breaker Assembly

5.	0396293	F-109	1-1/2" (38 mm) Elbow Flush Connection
6.	SEE SLIP JOINT GASKETS AND RINGS TABLE BELOW		
6A.	0306145	F-56-A	1-1/2" (38 mm) Spud Coupling Assembly
6B.	0306142	F-55-A	1-1/4" (32 mm) Spud Coupling Assembly
6C.	0306102	F-54-A	3/4" (19 mm) Spud Coupling Assembly

7.	—	F-7	Supply Flange (Supplied when Valve is not Ordered with Sweat Solder Kit)
8.	3308782	H-633-AA	1" (25 mm) Sweat Solder Kit with Cast Set Screw Flange
	3308788	H-636-AA	3/4" (19 mm) Sweat Solder Kit with Cast Set Screw Flange

9.	0378000PKSV-10		CP Sloan Cover
	0378003PKSV-10-HE		CP High Efficiency Sloan Cover
10.	3388015	H-1015	Flow Control Kit (not Shown)(HEU Only)

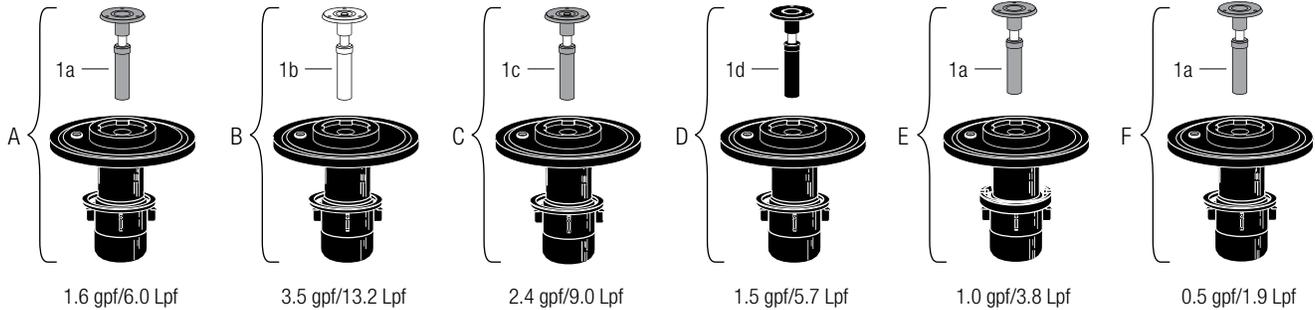
INSIDE COMPONENTS

Item No.	Code No.	Part No.	Description
1a.	5301211	A-19-ALC	Relief Valve, Green (Closet/Urinal-LC) – 12 per package
1b.	5301058	A-19-AC	Relief Valve, White (Closet) – 12 per package
1c.	0301143	A-19-AL	Relief Valve, Blue (9 Liter Closet)
1d.	5301059	A-19-AU	Relief Valve, Black (Urinal) – 12 per package
